Station Paper No. 55

December 1960

³
**A STUDY OF
EARLY GULLY-CONTROL STRUCTURES
in the Colorado Front Range**

by
Burchard H. Heede
Research Forester

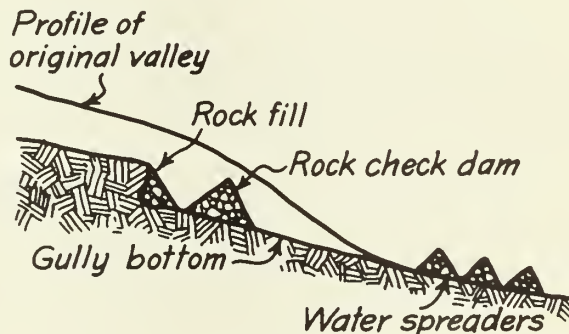
Figure 28.--

The discontinuous gully system was not treated. Treatment is necessary now to prevent the individual gullies from further expansion and coalescence (fig. 28).

Proposed treatment of
partially fused
discontinuous gullies.
